**Flood Control Project Maintenance
Levee Inspections**

Fall 2015 Levee Maintenance Deficiency Summary Report

Sacramento River Basin

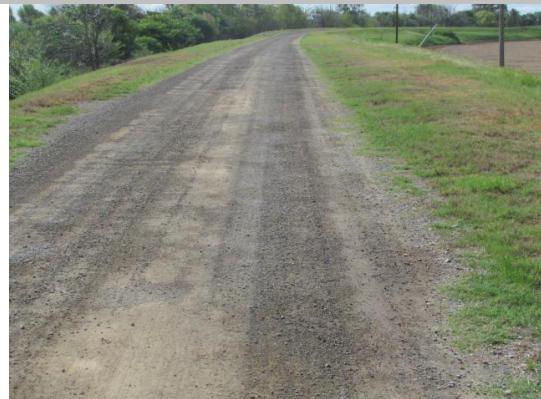
Photo 1 of 1 : FA_2015_RD0999_234_9_20150914_00009.jpg

LM Start	0.11	Rating **	M	Issue No.	9										
LM End	1.37	Issue Type +	Ma	Location *	CR										
Category	Earthen Levee			GPS Latitude/Longitude											
				Start	End										
Item	Crown Surface / Depressions / Rutting			38.287873 °	38.304451 °										
				-121.605108 °	-121.600419 °										
DWR ID	DWR_RD0999_03_f_2012_9														
Action/Comments															
Repair depressions or ruts in the crown or slope.

Looking south at levee crown. (Spring 2015)

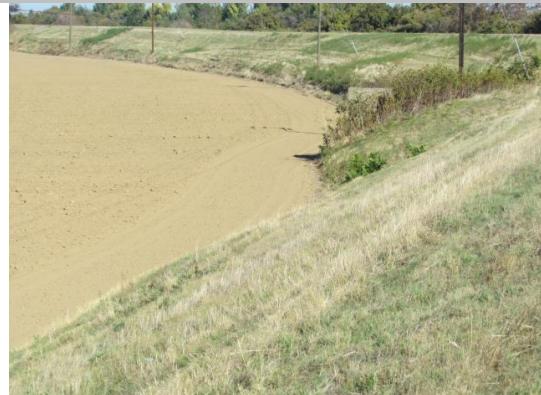
Photo 1 of 2 : FA_2015_RD0999_234_45_20150914_00031.jpg

LM Start	0.11	Rating **	A/W	Issue No.	45										
LM End	0.41	Issue Type +	En	Location *	LS										
Category	Earthen Levee			GPS Latitude/Longitude											
				Start	End										
Item	Encroachments			38.287929 °	38.292129 °										
				-121.605098 °	-121.604885 °										
DWR ID	DWR_RD0999_03_s_2014_45														
Action/Comments															
Crops

Looking north at proper toe road at landward toe. Fall 2014

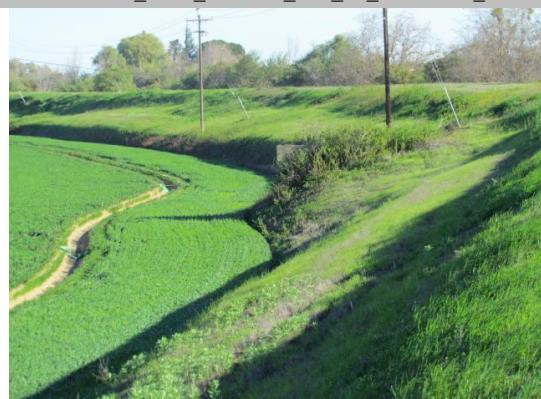
Photo 2 of 2 : FA_2015_RD0999_234_45_20150914_00032.jpg

Looking north at crops encroaching onto landside toe.

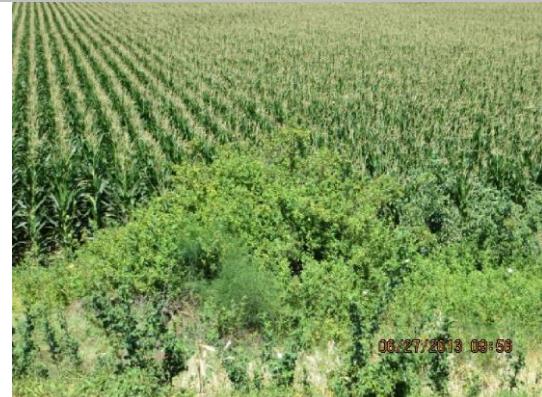
Photo 3 of 3 : UCIP_FA_2015_0991.jpg

LM Start	0.18	Rating **	M	Issue No.	51 (cont)									
LM End	0.18	Issue Type +	En	Location *	LS									
Category	Supplemental			GPS Latitude/Longitude										
				Start	End									
Item	DWR UCIP Field Study			38.288813 °	38.288813 °									
				-121.604670 °	-121.604670 °									
DWR ID														
Action/Comments														
Inspector Comments: FS_ID:15389 DS_ID:22776 EP_NO: N/A FS_HLM: 0.158 Repair Type: Non-Urgent Crossing Status: Found

Pumphouse on LS slope covered in rose bush.

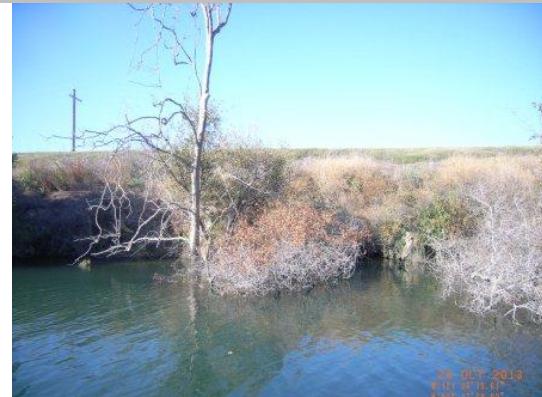
Photo 1 of 1 : USACE2013A_STR_24-7_R_12.jpg

Item	2015 USACE Erosion Survey, DRAFT			38.289634 °	38.295505 °									
				-121.604343 °	-121.605648 °									
DWR ID														
Action/Comments														
Inspector Comments: 1997 - Intermittent over-steepened sections. Large riparian vegetation along the length of the entire reach. Attempts to repair with rock on bank have failed. 1999 - New rock repair at the downstream end. 2002 - Some minor spot repairs. 2009 - Minimal new erosion. 2010 - Appears that fresh rock placed on downstream portion of site. Toe scour and overhanging trees with some overturned. 2012 - Minor new erosion at the toe. 2013 - Site upgraded to CRITICAL. Severe slumping into levee at downstream end of site. Fresh erosion into bank toe. 2015: New slumping, tall vertical sections. [2015 Site ID: STR_24-7_R]

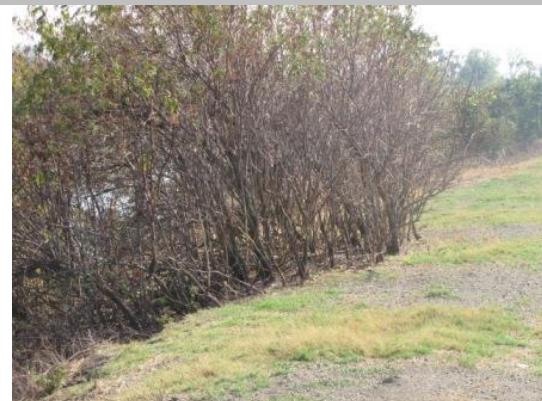
Photo 1 of 1 : FA_2015_RD0999_234_7_20150914_00007.jpg

LM Start	0.45	Rating **	M	Issue No.	7									
LM End	0.45	Issue Type +	Ma	Location *	WS									
Category	Earthen Levee			GPS Latitude/Longitude										
				Start	End									
Item	Vegetation			38.292748 °	38.292748 °									
				-121.604972 °	-121.604972 °									
DWR ID	DWR_RD0999_03_s_2012_7													
Action/Comments														
Elderberries are blocking visibility and flood fight capability.

Looking south at thinned Elderberry on waterside slope.

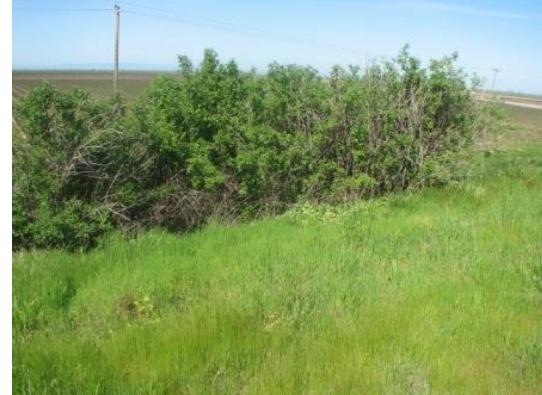
Photo 1 of 1 : FA_2015_RD0999_234_8_20150914_00008.jpg

LM Start	0.66	Rating **	M	Issue No.	8				
LM End	0.66	Issue Type +	Ma	Location *	LS				
Category	Earthen Levee			GPS Latitude/Longitude					
				Start	End				
Item	Vegetation			38.295618 °	38.295618 °				
				-121.605923 °	-121.605923 °				
DWR ID	DWR_RD0999_03_s_2012_8						Action/Comments		
	Elderberries are blocking visibility and flood fight capability.

Elderberries blocking view of landside toe.

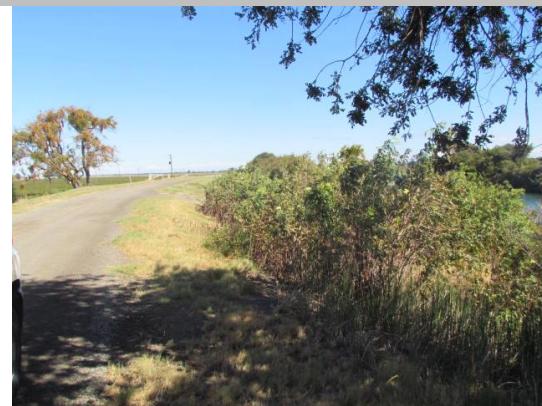
Photo 1 of 1 : FA_2015_RD0999_234_15_20150914_00014.jpg

LM Start	0.69	Rating **	M	Issue No.	15				
LM End	0.70	Issue Type +	Ma	Location *	WS				
Category	Earthen Levee			GPS Latitude/Longitude					
				Start	End				
Item	Vegetation			38.296073 °	38.296203 °				
				-121.605872 °	-121.605837 °				
DWR ID	DWR_RD0999_03_s_2012_15						Action/Comments		
	Elderberries are blocking visibility and flood fight capability.

Looking northeast at dense elderberry on waterward slope.

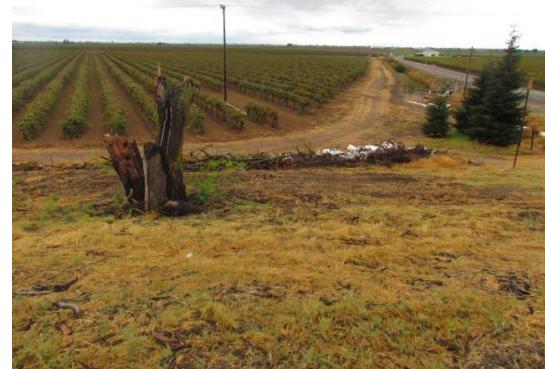
LM Start	0.75	Rating **	M	Issue No.	2										
LM End	0.75	Issue Type +	Ma	Location *	LS										
Category	Earthen Levee			GPS Latitude/Longitude											
				Start	End										
Item	Encroachments			38.296942 °	38.296942 °										
				-121.605528 °	-121.605528 °										
DWR ID	DWR_RD0999_03_s_2012_2						Photo 1 of 1 : FA_2015_RD0999_234_2_20151106_00038.jpg								
Action/Comments															
Prunings

Looking at prunings at landward toe.

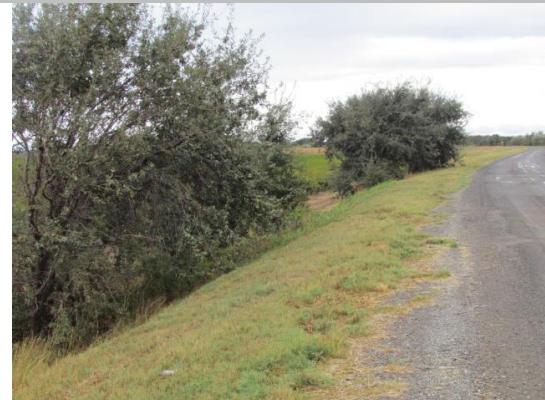
LM Start	0.93	Rating **	U	Issue No.	43										
LM End	0.95	Issue Type +	Ma	Location *	LS										
Category	Earthen Levee			GPS Latitude/Longitude											
				Start	End										
Item	Trim / Thin Trees			38.299130 °	38.299362 °										
				-121.603768 °	-121.603462 °										
DWR ID	DWR_RD0999_03_f_2014_43						Photo 1 of 1 : FA_2015_RD0999_234_43_20151106_00039.jpg								
Action/Comments															
Trim trees to at least five feet above ground level.

Looking at untrimmed trees on landward slope and toe.

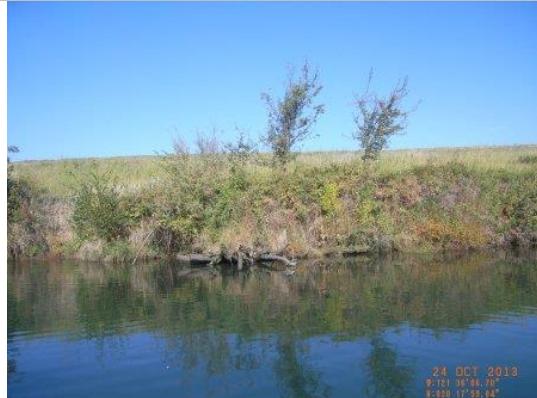
Photo 1 of 1 : USACE2013A_STR_25-2_R_11.jpg

LM Start	0.97	Rating **	M	Issue No.	30									
LM End	1.10	Issue Type +	Ma	Location *	WS									
Category	Supplemental			GPS Latitude/Longitude										
				Start	End									
Item	2015 USACE Erosion Survey, DRAFT			38.299402 °	38.300542 °									
DWR ID														
Action/Comments														
Inspector Comments: 2008 - Over steepened levee section. 2009 - Significant new erosion. 2010 - Minor new erosion. 2015: No observed changes. [2015 Site ID: STR_25-2_R]

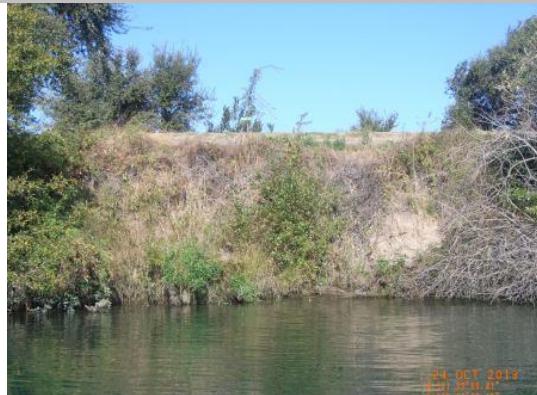
Photo 1 of 1 : USACE2013A_STR_25-7_R_11.jpg

LM Start	1.43	Rating **	M	Issue No.	1									
LM End	1.58	Issue Type +	Ma	Location *	WS									
Category	Supplemental			GPS Latitude/Longitude										
				Start	End									
Item	2015 USACE Erosion Survey, DRAFT			38.305229 °	38.306667 °									
DWR ID														
Action/Comments														
Inspector Comments: 2011 - Toe scour along length of site and erosion pockets. 2012 - Site extended slightly upstream due to new erosion pocket. 2013 - Tall vertical sections at upstream end of site. 2015: No observed changes. [2015 Site ID: STR_25-7_R]

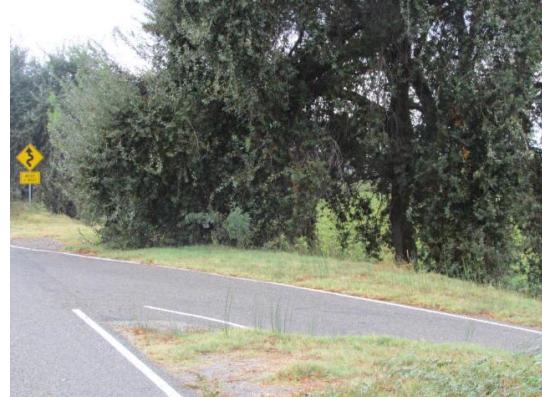
Photo 1 of 1 : FA_2015_RD0999_234_11_20151106_00040.jpg

LM Start	1.50	Rating **	U	Issue No.	11										
LM End	1.50	Issue Type +	Ma	Location *	LS										
Category	Earthen Levee			GPS Latitude/Longitude											
				Start	End										
Item	Trim / Thin Trees			38.306062 °	38.306062 °										
				-121.599495 °	-121.599495 °										
DWR ID	DWR_RD0999_03_s_2012_11														
Action/Comments															
Trim trees to at least five feet above ground level.

Looking at untrimmed trees on landward slope and toe.

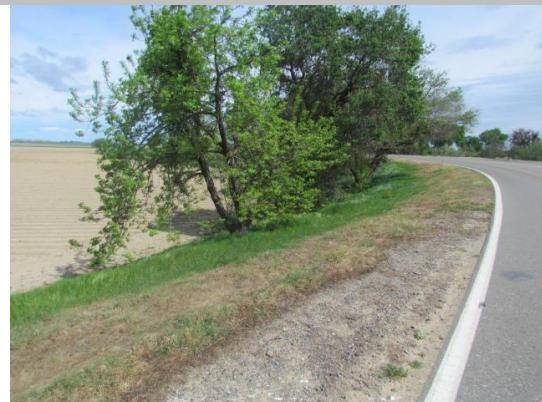
Photo 1 of 1 : FA_2015_RD0999_234_13_20150914_00013.jpg

LM Start	1.57	Rating **	M	Issue No.	13										
LM End	1.59	Issue Type +	Ma	Location *	LS										
Category	Earthen Levee			GPS Latitude/Longitude											
				Start	End										
Item	Trim / Thin Trees			38.306762 °	38.306948 °										
				-121.598541 °	-121.598320 °										
DWR ID	DWR_RD0999_03_s_2012_13														
Action/Comments															
Trim and thin trees to allow visibility of the ground and room to flood fight.

Looking north at untrimmed trees on landward toe. (Spring 2015)

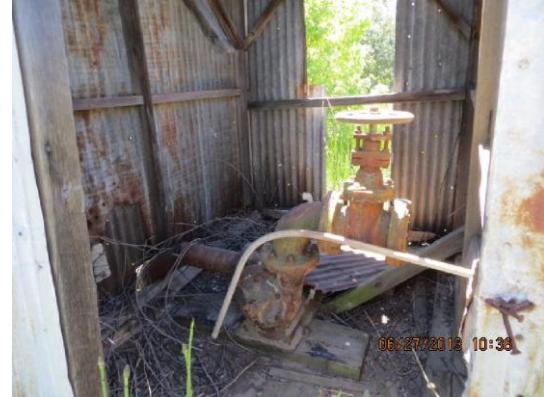
Photo 1 of 3 : UCIP_FA_2015_1048.jpg

LM Start	1.71	Rating **	M	Issue No.	52							
LM End	1.71	Issue Type +	En	Location *	LS							
Category	Supplemental			GPS Latitude/Longitude								
				Start	End							
Item	DWR UCIP Field Study			38.308513 °	38.308513 °							
				-121.598874 °	-121.598874 °							
DWR ID												
Action/Comments												
Inspector Comments: FS_ID:15392 DS_ID:22779 EP_NO: N/A FS_HLM: 1.702 Repair Type: Non-Urgent Crossing Status: Found UCIP Comments: Pipe abandoned and should be verified as being done so properly. FIELD_STRUCT_DESC: *Abandoned* 5-inch pipe through levee 4.4 feet below crown. Pump and valve in pump house on the waterward slope (couldn't see landward end of pipe 2/91). 1-inch galvanized iron electric conduit at same location. Originally included in the 1966 O&M manual. FS Date: 06/27/2013

gatevalve inside pumphouse with no connection.

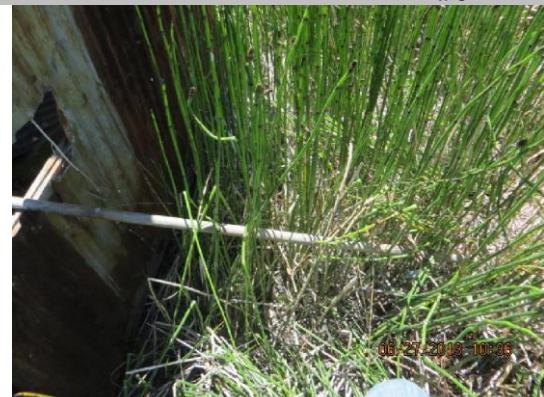
Photo 2 of 3 : UCIP_FA_2015_1049.jpg

1-inch galvanized iron electrical conduit on WS slope.

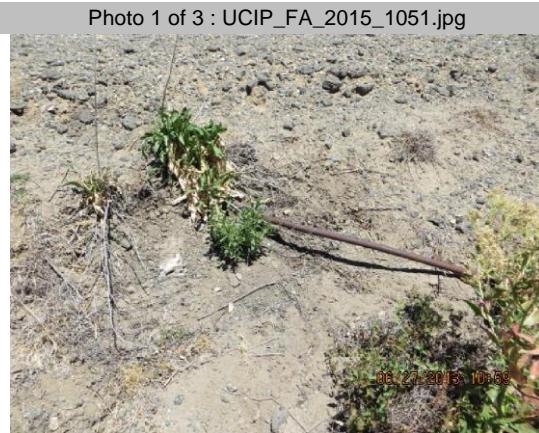
LM Start	2.00	Rating **	M	Issue No.	53												
LM End	2.00	Issue Type +	En	Location *	LS												
Category	Supplemental				GPS Latitude/Longitude												
					Start	End											
Item	DWR UCIP Field Study				38.311709 °	38.311709 °											
DWR ID					-121.596713 °	-121.596713 °											
Action/Comments																	
Inspector Comments: FS_ID:15393 DS_ID:22780 EP_NO: N/A FS_HLM: 2 Repair Type: Non-Urgent Crossing Status: Found UCIP Comments: Pipe abandoned and should be done so properly. FIELD_STRUCT_DESC: 7-inch pipe through levee 4.6 feet below crown. Pump and gate valve on waterward slope. Service pole on the landward slope. 1-inch galvanized iron electrical conduit at same location. Originally included in the 1966 O&M manual. FS Date: 06/27/2013

Galvanized iron pipe on WS slope.

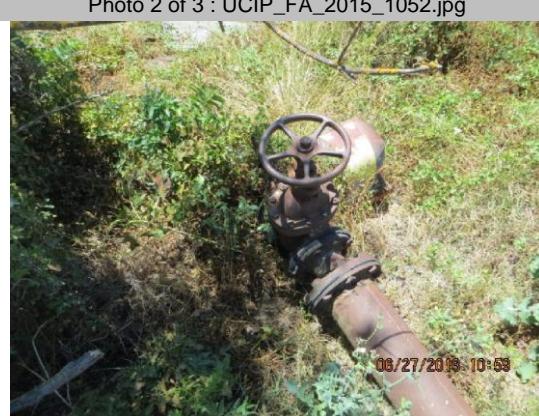
Gate valve on WS slope at pump.

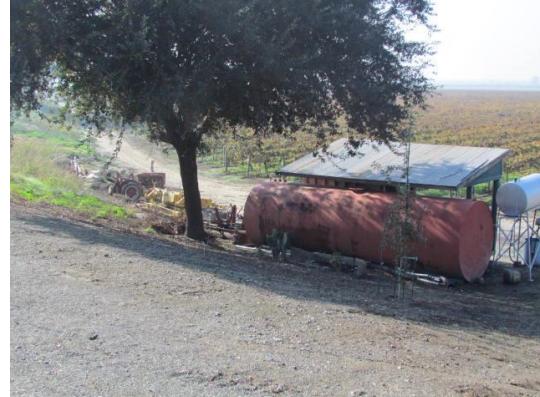
Photo 1 of 2 : FA_2015_RD0999_234_27_20150914_00019.jpg

LM Start	2.54	Rating **	M	Issue No.	27										
LM End	2.54	Issue Type +	Ma	Location *	LS										
Category	Earthen Levee			GPS Latitude/Longitude											
				Start	End										
Item	Encroachments			38.317840 °	38.317840 °										
				-121.590895 °	-121.590895 °										
DWR ID	DWR_RD0999_03_s_2012_27														
Action/Comments															
Equipment Inspector Comments: Diesel tank stored at landside toe.

Looking southwest at farm equipment stored at landside toe. (Fall Inspection 2012)

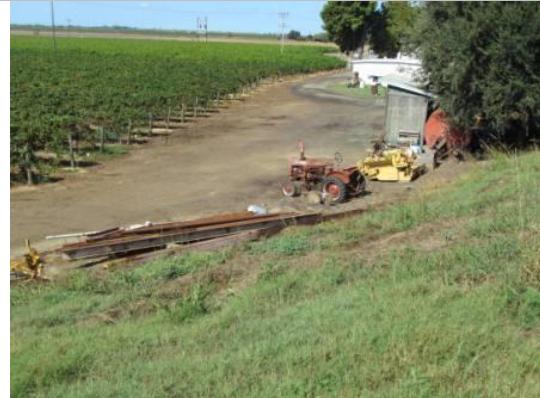
Photo 2 of 2 : FA_2015_RD0999_234_27_20150914_00020.jpg

Looking northwest at equipment at landside toe.

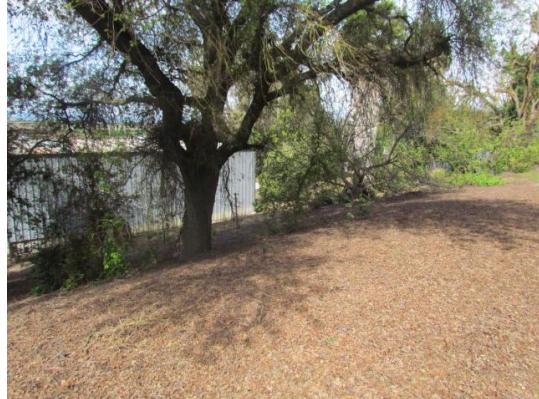
Photo 1 of 1 : FA_2015_RD0999_234_32_20150914_00024.jpg

LM Start	2.69	Rating **	A/W	Issue No.	32										
LM End	2.74	Issue Type +	Ma	Location *	LS										
Category	Earthen Levee			GPS Latitude/Longitude											
				Start	End										
Item	Trim / Thin Trees			38.319943 °	38.320670 °										
				-121.590737 °	-121.590802 °										
DWR ID	DWR_RD0999_03_s_2012_32														
Action/Comments															
Trim trees to at least five feet above ground level.

Looking northwest at untrimmed trees on landward slope. (Spring 2015)

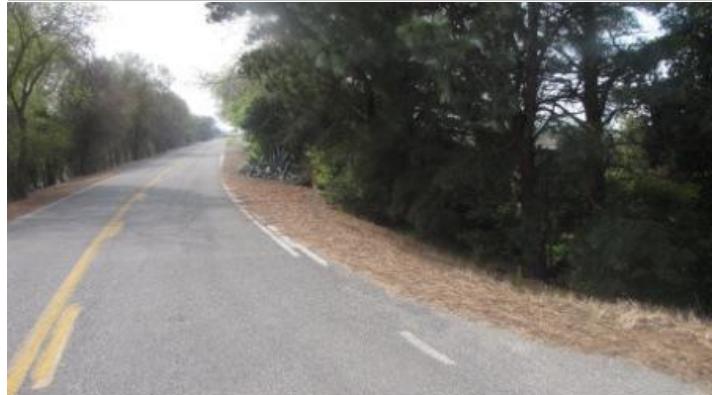
Photo 1 of 2 : FA_2015_RD0999_234_16_20150914_00015.jpg

LM Start	2.70	Rating **	A/W	Issue No.	16										
LM End	2.71	Issue Type +	En	Location *	LS										
Category	Earthen Levee			GPS Latitude/Longitude											
				Start	End										
Item	Vegetation			38.320105 °	38.320340 °										
				-121.590765 °	-121.590730 °										
DWR ID	DWR_RD0999_03_s_2012_16														
Action/Comments															
Landscaping

Looking south at landscaping and dense veg. on landside slope and toe.

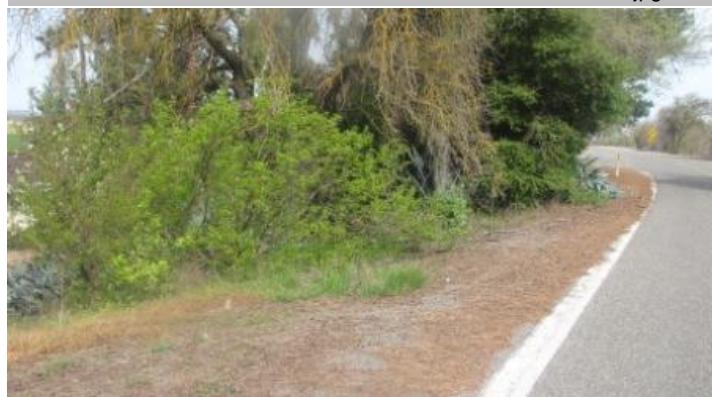
Photo 2 of 2 : FA_2015_RD0999_234_16_20150914_00016.jpg

Looking northwest at landscaping and dense veg. on landside slope and toe.

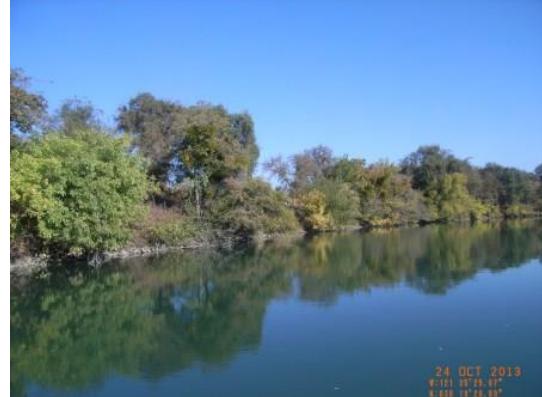
Photo 1 of 1 : USACE2013A_STR_27-1_R_2.jpg

LM Start	2.87	Rating **	M	Issue No.	21																		
LM End	2.92	Issue Type +	Ma	Location *	WS																		
Category	Supplemental			GPS Latitude/Longitude																			
				Start	End																		
Item	2015 USACE Erosion Survey, DRAFT			38.322457 °	38.323042 °																		
DWR ID																							
Action/Comments																							
Inspector Comments: 2012 - Slumping of upper levee slope. 2015: No observed changes. [2015 Site ID: STR_27-1_R]

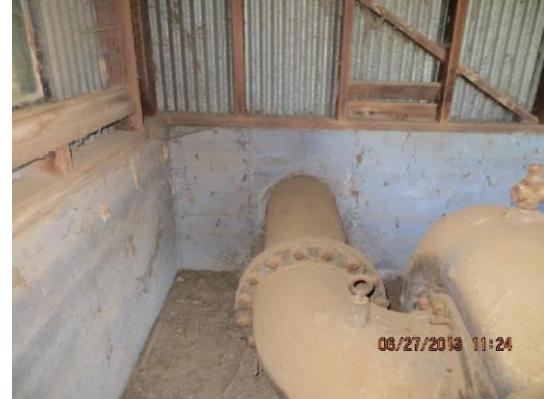
Photo 1 of 3 : UCIP_FA_2015_1066.jpg

LM Start	2.88	Rating **	M	Issue No.	54																		
LM End	2.88	Issue Type +	En	Location *	WS																		
Category				GPS Latitude/Longitude																			
				Start	End																		
Item				DWR UCIP Field Study	38.322652 °	38.322652 °																	
					-121.590841 °	-121.590841 °																	
DWR ID																							
Action/Comments																							
Inspector Comments: FS_ID:15406 DS_ID:22782 EP_NO: N/A FS_HLM: 2.886 Repair Type: Non-Urgent Crossing Status: Found UCIP Comments: This pipe is abandoned and should be done so properly. FIELD_STRUCT_DESC: *Abandoned* 16-inch pipe through levee 9.3 feet below crown. Pump and gate valve in pump house on the landward slope. Originally included in the 1966 O&M manual. FS Date: 06/27/2013

Pipe entering levee at LS toe.

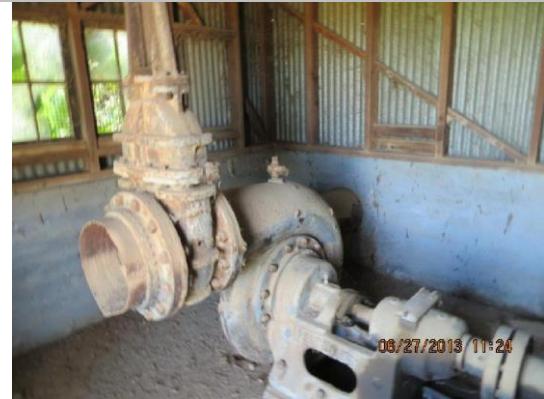
Photo 2 of 3 : UCIP_FA_2015_1067.jpg

Pump and gatevalve inside pumphouse at LS toe.

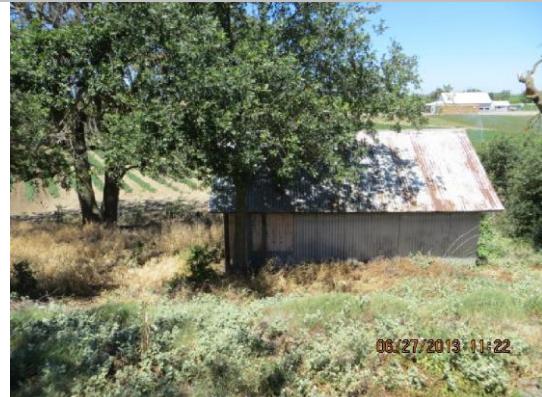
Photo 3 of 3 : UCIP_FA_2015_1068.jpg

Pumphouse on LS toe.

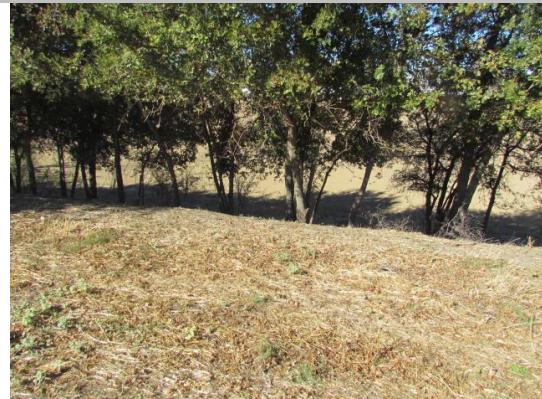
Photo 1 of 3 : FA_2015_RD0999_234_10_20150914_00010.jpg

LM Start	2.88	Rating **	M	Issue No.	10									
LM End	2.88	Issue Type +	Ma	Location *	LS									
Category	Earthen Levee			GPS Latitude/Longitude										
				Start	End									
Item	Vegetation			38.322757 °	38.322757 °									
				-121.590817 °	-121.590817 °									
DWR ID	DWR_RD0999_03_f_2012_10													
Action/Comments														
Remove the wild growth other than native grasses from the levee slopes. Inspector Comments: Wild growth at landside slope and toe.

Looking west at trimmed trees at landward toe. (Fall 2014)

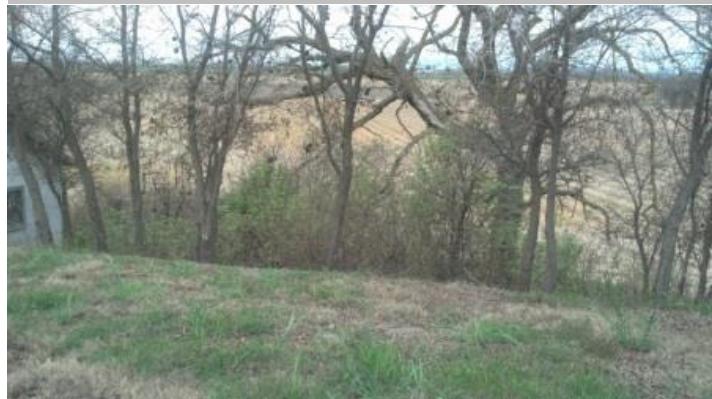
Photo 2 of 3 : FA_2015_RD0999_234_10_20150914_00011.jpg

Looking west at dense trees on landside toe.

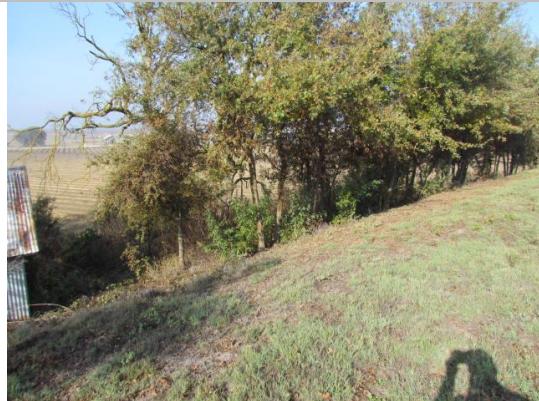
Photo 3 of 3 : FA_2015_RD0999_234_10_20150914_00012.jpg

LM Start	2.88	Rating **	M	Issue No.	10 (cont)												
LM End	2.88	Issue Type +	Ma	Location *	LS												
Category	Earthen Levee			GPS Latitude/Longitude													
				Start	End												
Item	Vegetation			38.322757 °	38.322757 °												
				-121.590817 °	-121.590817 °												
DWR ID	DWR_RD0999_03_f_2012_10																
Action/Comments																	
Remove the wild growth other than native grasses from the levee slopes.																	
Inspector Comments: Wild growth at landside slope and toe.

Looking northwest at dense vegetation at landside slope and toe.

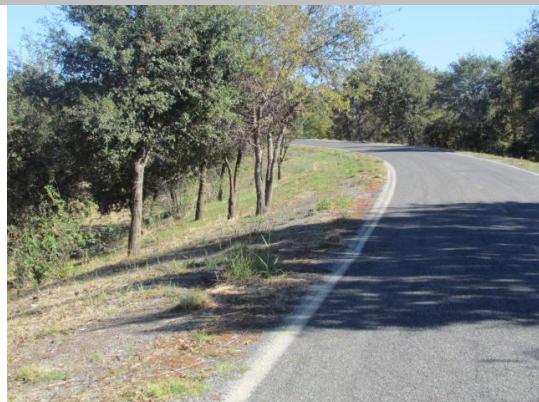
Photo 1 of 1 : FA_2015_RD0999_234_31_20150914_00023.jpg

LM Start	3.01	Rating **	M	Issue No.	31												
LM End	3.25	Issue Type +	Ma	Location *	LS												
Category	Earthen Levee			GPS Latitude/Longitude													
				Start	End												
Item	Trim / Thin Trees			38.323770 °	38.326061 °												
				-121.589035 °	-121.586028 °												
DWR ID	DWR_RD0999_03_s_2012_31																
Action/Comments																	
Trim and thin trees to allow visibility of the ground and room to flood fight.

Looking north at trimmed trees on landward slope.

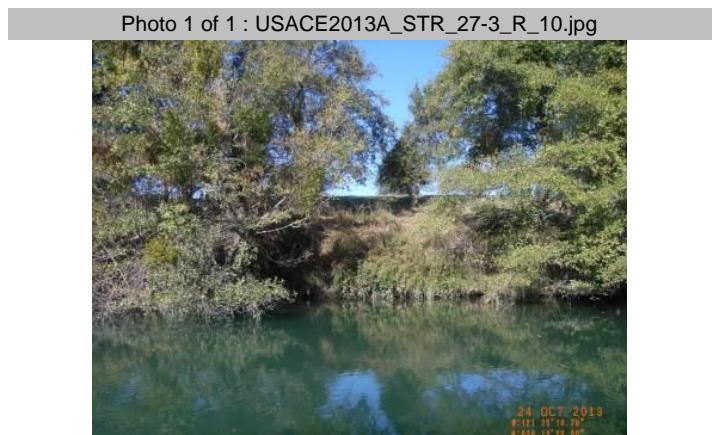
LM Start	3.05	Rating **	M	Issue No.	5													
LM End	3.23	Issue Type +	Ma	Location *	WS													
Category	Supplemental			GPS Latitude/Longitude														
				Start	End													
Item	2015 USACE Erosion Survey, DRAFT			38.323667 °	38.325592 °													
				-121.588226 °	-121.585925 °													
DWR ID																		
Action/Comments																		
Inspector Comments: 2011 - Multiple erosion pockets. Some likely from tree popouts. 2013 - Tall vertical sections. 2015: New tree popout and significant new erosion. [2015 Site ID: STR_27-3_R]

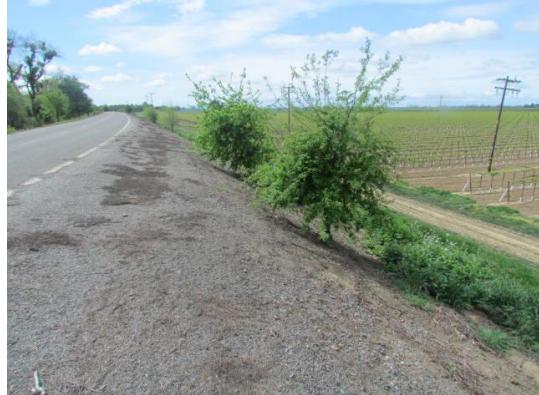
Photo 1 of 1 : FA_2015_RD0999_234_44_20150914_00030.jpg

LM Start	3.60	Rating **	M	Issue No.	44										
LM End	3.64	Issue Type +	Ma	Location *	LS										
Category	Earthen Levee			GPS Latitude/Longitude											
				Start	End										
Item	Trim / Thin Trees			38.330946 °	38.331415 °										
				-121.585932 °	-121.585534 °										
DWR ID	DWR_RD0999_03_s_2015_44														
Action/Comments															
Thin trees to allow visibility of the ground and room to flood fight. Inspector Comments: Remove trees under an inch in diameter. Don't allow young trees to get establish on levee slope.

Looking southwest at typical view of young oak trees on landward slope.
(Spring 2015)

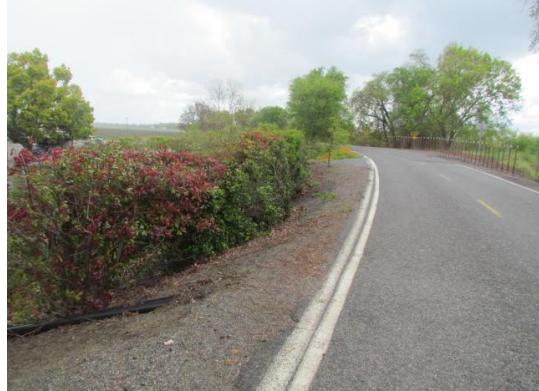
Photo 1 of 2 : FA_2015_RD0999_234_22_20150914_00017.jpg

LM Start	3.70	Rating **	U	Issue No.	22										
LM End	3.71	Issue Type +	En	Location *	LS										
Category	Earthen Levee			GPS Latitude/Longitude											
				Start	End										
Item	Vegetation			38.332017 °	38.332156 °										
				-121.584807 °	-121.584707 °										
DWR ID	DWR_RD0999_03_s_2012_22														
Action/Comments															
Landscaping

Looking southwest at trimmed landscaping on landside slope, but still blocking levee slope.

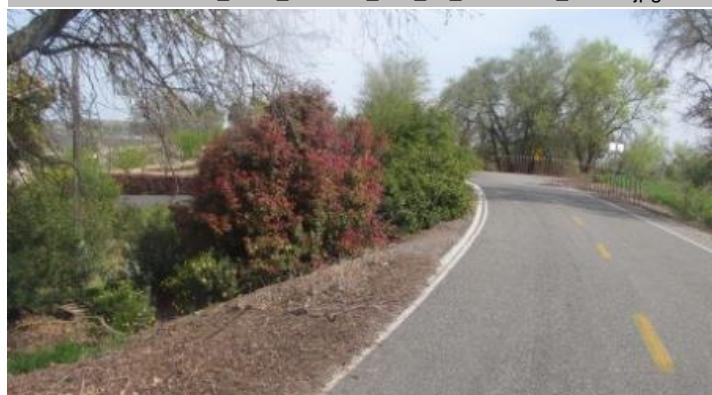
Photo 2 of 2 : FA_2015_RD0999_234_22_20150914_00018.jpg

Looking northwest at landscaping on landside slope and toe. (Spring 2011)

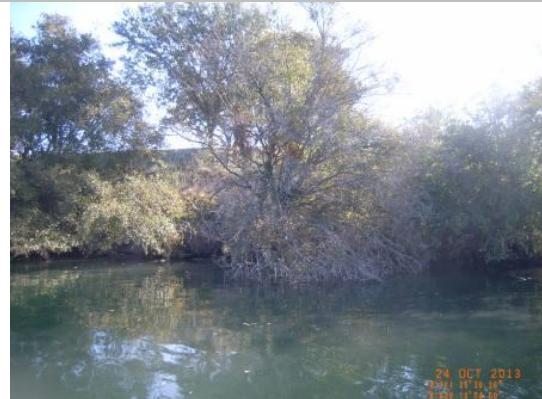
Photo 1 of 1 : USACE2013A_STR_26-5_L_8.jpg

LM Start	4.56	Rating **	M	Issue No.	18											
LM End	4.68	Issue Type +	Ma	Location *	WS											
Category	Supplemental			GPS Latitude/Longitude												
				Start	End											
Item	2015 USACE Erosion Survey, DRAFT			38.313836 °	38.315407 °											
				-121.592259 °	-121.591433 °											
DWR ID																
Action/Comments																
Inspector Comments: 2002 - Original rock over geotextile is sliding off and the end is coming unraveled. 2003 - Some minor new erosion on the downstream end. 2004 - Site has gotten worse. Underlined geofabric is exposed. 2005 - Still looks bad with exposed geotextile fabric. 2006 - Still have some new unraveling and exposed fabric. Site lengthened upstream. 2009 - Minimal new erosion. 2010 - geotextile

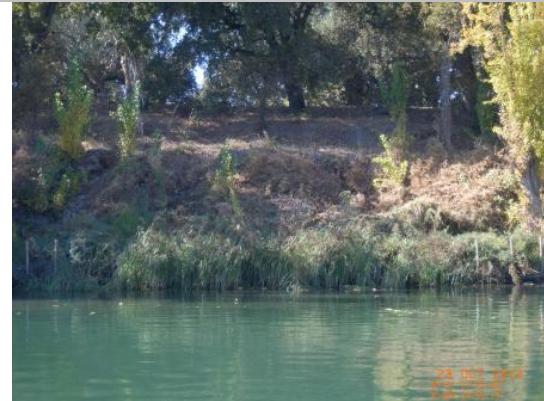
Photo 1 of 1 : USACE2013A_SAC_41-9_R_14.jpg

LM Start	0.02	Rating **	M	Issue No.	8									
LM End	0.28	Issue Type +	Ma	Location *	WS									
Category	Supplemental			GPS Latitude/Longitude										
				Start	End									
Item	2015 USACE Erosion Survey, DRAFT			38.414387 °	38.417692 °									
				-121.522871 °	-121.525083 °									
DWR ID														
Action/Comments														
Inspector Comments: 1997 - Structural problem rather than erosional, failed cobble at downstream end. 2005 - New brush boxes at waterline for several hundred feet downstream, No toe or bank protection present. 2006 - Some minor new erosion. Brush boxes not working well; most of the brush has floated out. 2007 - Brush boxes have recently been repaired. 2015: No observed changes. [2015 Site ID: SAC_41-9_R]

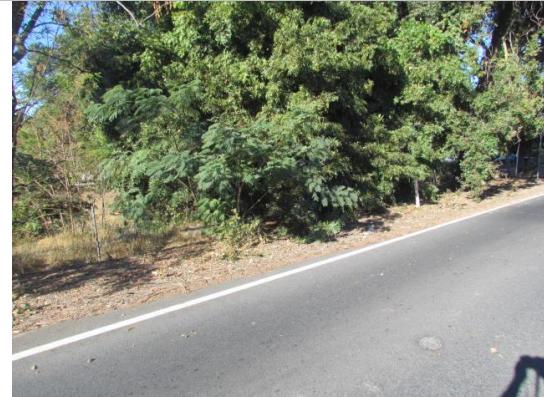
Photo 1 of 1 : FA_2015_RD0999_235_35_20151106_00027.jpg

LM Start	0.03	Rating **	U	Issue No.	35									
LM End	0.03	Issue Type +	Ma	Location *	LS									
Category	Earthen Levee			GPS Latitude/Longitude										
				Start	End									
Item	Trim / Thin Trees			38.414450 °	38.414450 °									
				-121.523308 °	-121.523308 °									
DWR ID	DWR_RD0999_04_f_2014_35													
Action/Comments														
Trim trees to at least five feet above ground level. Inspector Comments: Untrimmed trees on landward slope and toe.

Looking at untrimmed trees on landward slope.

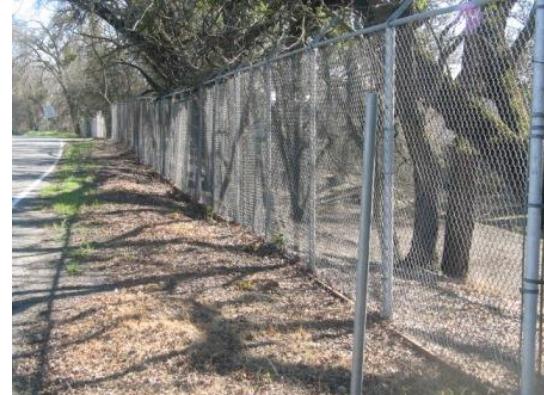
Photo 1 of 1 : FA_2015_RD0999_235_13_20150914_00013.jpg

LM Start	0.05	Rating **	M	Issue No.	13										
LM End	0.11	Issue Type +	En	Location *	LS										
Category	Earthen Levee			GPS Latitude/Longitude											
				Start	End										
Item	Encroachments			38.414672 °	38.415468 °										
				-121.523527 °	-121.524037 °										
DWR ID	DWR_RD0999_04_s_2012_13														
Action/Comments															
Fence

Cyclone fence along landside shoulder at LM 0.05 -0.11

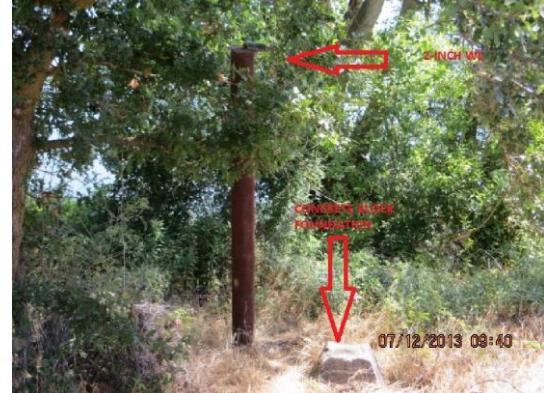
Photo 1 of 3 : UCIP_FA_2015_1449.jpg

LM Start	0.07	Rating **	M	Issue No.	41										
LM End	0.07	Issue Type +	En	Location *	LS										
Category	Supplemental			GPS Latitude/Longitude											
				Start	End										
Item	DWR UCIP Field Study			38.414881 °	38.414881 °										
				-121.523682 °	-121.523682 °										
DWR ID															
Action/Comments															
Inspector Comments: FS_ID:15709 DS_ID:22789 EP_NO: N/A FS_HLM: 0.067 Repair Type: Non-Urgent Crossing Status: Found UCIP Comments: Pipe abandoned and should be done so properly. FIELD_STRUCT_DESC: 2-inch pipe through levee 4.5 feet below crown. Concrete blocks for missing Pump and pressure system visible on WS slope. 8-inch steel standpipe on WS toe with remnants of 2-inch pipe visible at top. Pipe visible at concrete foundation on LS shoulder. Originally included in the 1966 O&M manual. FS Date: 07/12/2013

Pipe visible at top of steel standpipe. Foundation for pump station visible on WS slope.

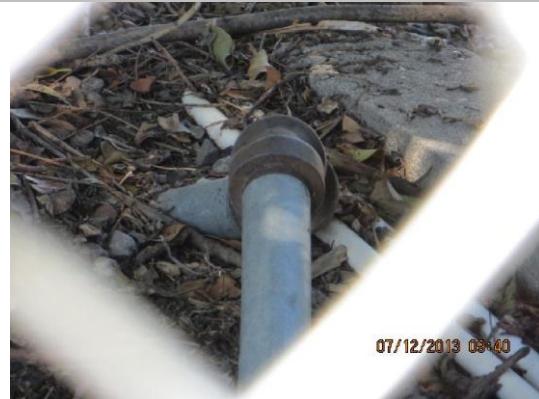
Photo 2 of 3 : UCIP_FA_2015_1450.jpg

Pipe visible at concrete foundation on LS shoulder.

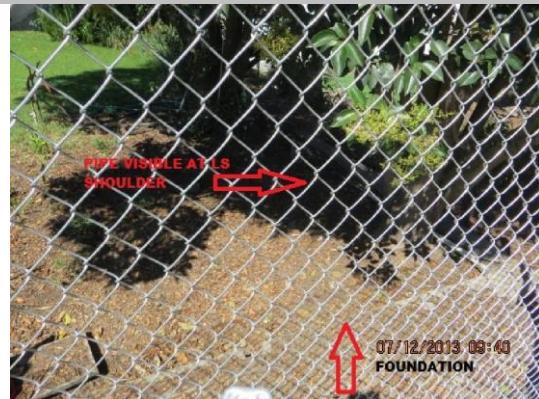
Photo 3 of 3 : UCIP_FA_2015_1451.jpg

Pipe visible at concrete foundation on LS shoulder.

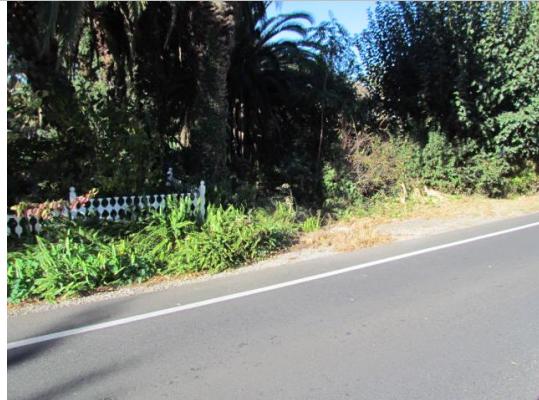
Photo 1 of 2 : FA_2015_RD0999_235_38_20151106_00028.jpg

LM Start	0.16	Rating **	U	Issue No.	38		
LM End	0.16	Issue Type +	En	Location *	LS		
Category	Earthen Levee			GPS Latitude/Longitude			
				Start	End		
Item	Vegetation			38.416040 °	38.416040 °		
				-121.524282 °	-121.524282 °		
DWR ID	DWR_RD0999_04_f_2015_38						
Action/Comments							
Landscaping Inspector Comments: Dense landscaping on landward slope and toe.

Looking northwest at dense landscaping on landward slope and toe.

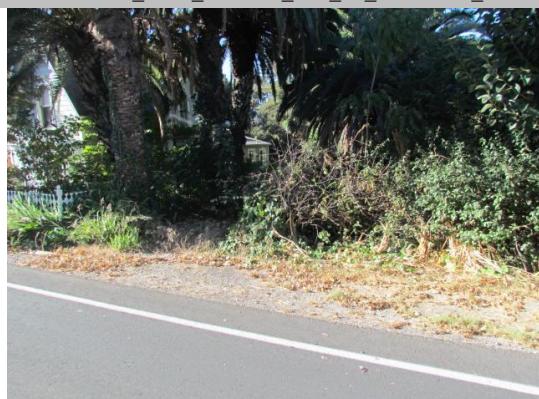
Photo 2 of 2 : FA_2015_RD0999_235_38_20151106_00029.jpg

Looking southwest at dense landscaping on landward slope and toe.

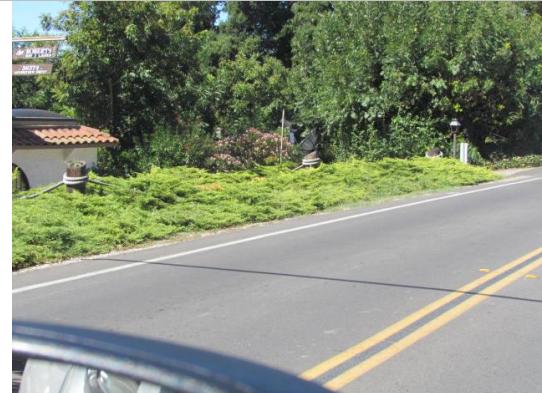
Photo 1 of 1 : FA_2015_RD0999_235_20_20150914_00016.jpg

LM Start	0.28	Rating **	M	Issue No.	20		
LM End	0.30	Issue Type +	En	Location *	LS		
Category	Earthen Levee			GPS Latitude/Longitude			
				Start	End		
Item	Vegetation			°	°		
				°	°		
DWR ID	DWR_RD0999_04_f_2013_20						Action/Comments
Landscaping

Looking west at dense landscaping on landward slope.

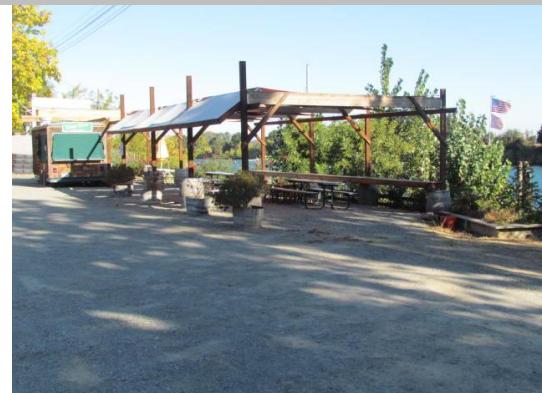
Photo 1 of 3 : FA_2015_RD0999_235_36_20151106_00030.jpg

LM Start	0.29	Rating **	U	Issue No.	36		
LM End	0.29	Issue Type +	En	Location *	WS		
Category	Earthen Levee			GPS Latitude/Longitude			
				Start	End		
Item	Encroachments			38.417809 °	38.417809 °		
				-121.525488 °	-121.525488 °		
DWR ID	DWR_RD0999_04_f_2014_36						Action/Comments
Building Inspector Comments: Landowner built patio structure next to mobile diner on waterward shoulder area without Board permit.

Looking northeast at patio on waterward shoulder.

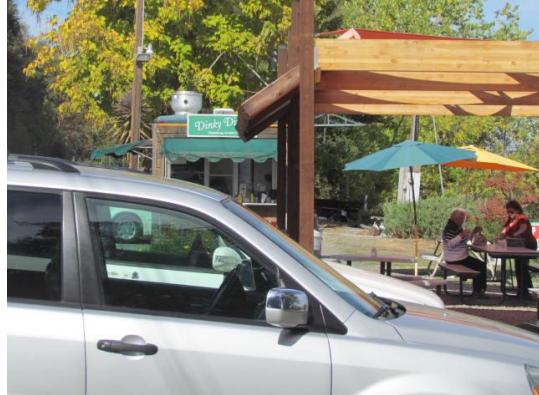
Photo 2 of 3 : FA_2015_RD0999_235_36_20150914_00019.jpg

Looking north at patio structure on waterward shoulder.

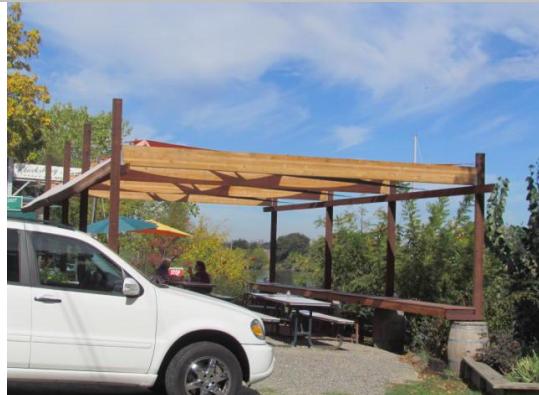
Photo 3 of 3 : FA_2015_RD0999_235_36_20150914_00020.jpg

Looking northeast at patio structure on waterward shoulder.

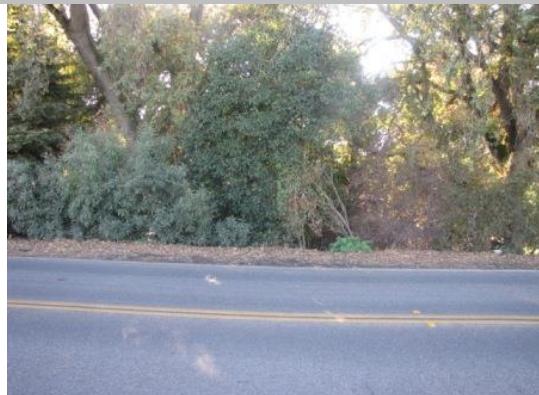
Photo 1 of 2 : FA_2015_RD0999_235_12_20150914_00011.jpg

LM Start	0.31	Rating **	U	Issue No.	12													
LM End	0.35	Issue Type +	En	Location *	LS													
Category	Earthen Levee			GPS Latitude/Longitude														
				Start	End													
Item	Vegetation			38.418002 °	38.418470 °													
				-121.525712 °	-121.526002 °													
DWR ID	DWR_RD0999_04_s_2012_12																	
Action/Comments																		
Landscaping

Looking west at dense vegetation on landside slope and toe.

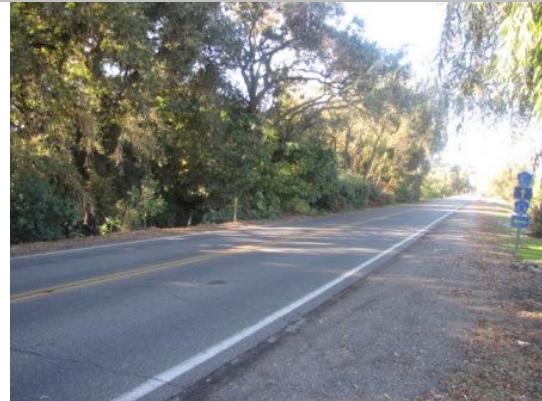
Photo 2 of 2 : FA_2015_RD0999_235_12_20150914_00012.jpg

Looking northwest at dense vegetation on landside shoulder and slope.

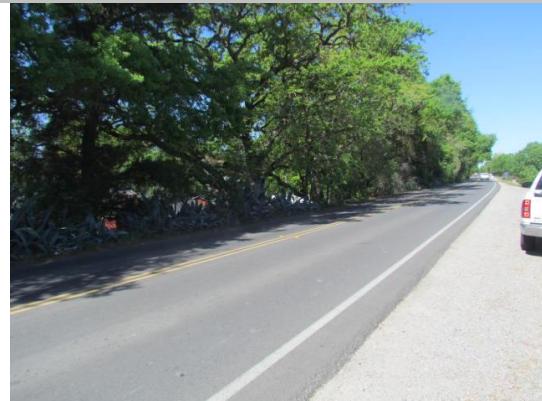
Photo 1 of 2 : FA_2015_RD0999_235_11_20150914_00009.jpg

LM Start	0.38	Rating **	U	Issue No.	11												
LM End	0.49	Issue Type +	En	Location *	LS												
Category	Earthen Levee			GPS Latitude/Longitude													
				Start	End												
Item	Vegetation			38.418838 °	38.420237 °												
				-121.526225 °	-121.527193 °												
DWR ID	DWR_RD0999_04_s_2012_11																
Action/Comments																	
Landscaping

Looking northwest at dense landscaping on landward slope. (Spring 2015)

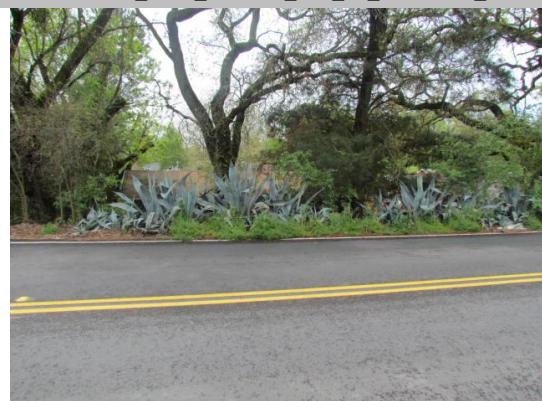
Photo 2 of 2 : FA_2015_RD0999_235_11_20150914_00010.jpg

Looking west at century plants on landside shoulder and slope.

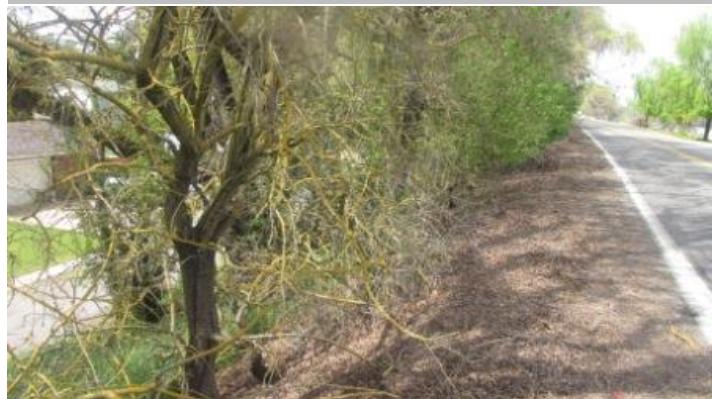
Photo 1 of 2 : FA_2015_RD0999_235_10_20150914_00007.jpg

Looking northwest at dense trees on landside slope and toe.

LM Start	0.38	Rating **	M	Issue No.	10										
LM End	0.50	Issue Type +	Ma	Location *	LS										
Category	Earthen Levee			GPS Latitude/Longitude											
				Start	End										
Item	Trim / Thin Trees			38.418838 °	38.420447 °										
				-121.526225 °	-121.527380 °										
DWR ID	DWR_RD0999_04_s_2012_10														
Action/Comments															
Trim trees to at least five feet above ground level.

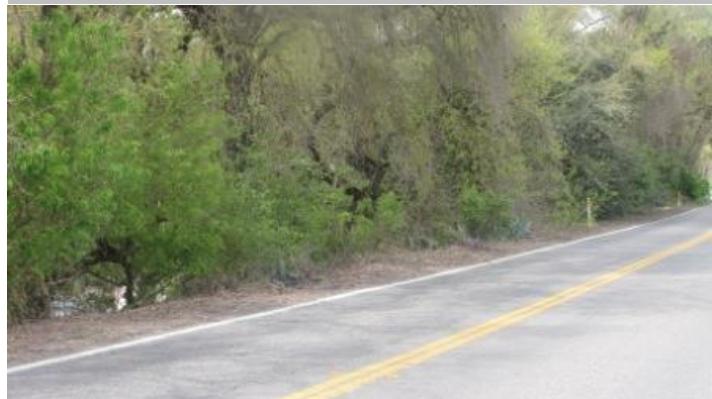
Photo 2 of 2 : FA_2015_RD0999_235_10_20150914_00008.jpg

Looking west at dense trees on waterside slope.

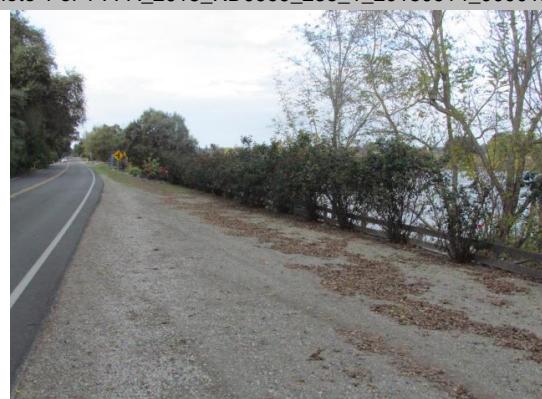
Photo 1 of 1 : FA_2015_RD0999_235_1_20150914_00001.jpg

LM Start	0.40	Rating **	M	Issue No.	1										
LM End	0.47	Issue Type +	En	Location *	WS										
Category	Earthen Levee			GPS Latitude/Longitude											
				Start	End										
Item	Vegetation			38.419137 °	38.420078 °										
				-121.526280 °	-121.526913 °										
DWR ID	DWR_RD0999_04_s_2012_1														
Action/Comments															
Landscaping

Looking north at rose bushes on waterside slope.

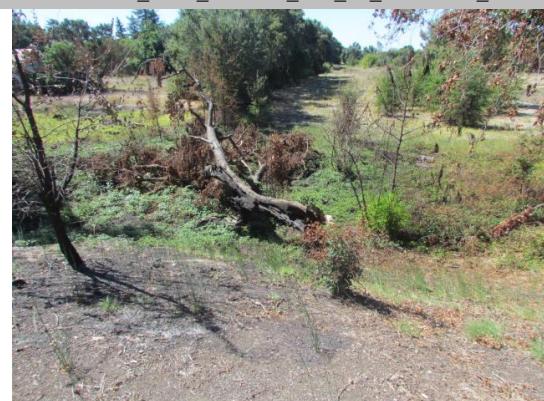
LM Start	0.60	Rating **	A/W	Issue No.	21		Photo 1 of 1 : FA_2015_RD0999_235_21_20150914_00017.jpg										
LM End	0.60	Issue Type +	Ma	Location *	LS												
Category	Earthen Levee			GPS Latitude/Longitude													
				Start	End												
Item	Encroachments			°	°												
				°	°												
DWR ID	DWR_RD0999_04_f_2013_21																
Action/Comments																	
Tree or limb Inspector Comments: Downed tree on landward toe and berm.

Looking west at dead tree on landward toe and berm.

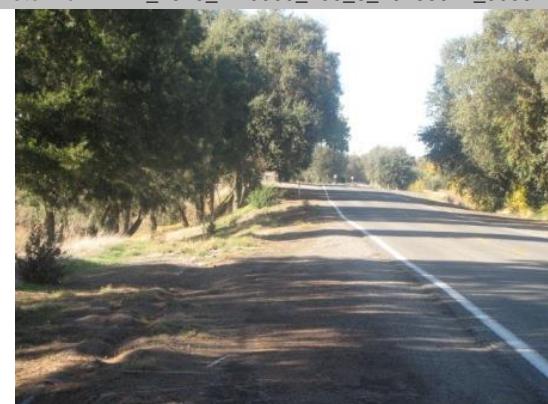
Looking north at trimmed trees and removed fence on landside slope.

LM Start	0.71	Rating **	A/W	Issue No.	6		Photo 1 of 2 : FA_2015_RD0999_235_6_20150914_00004.jpg						
LM End	0.87	Issue Type +	Ma	Location *	LS								
Category	Earthen Levee			GPS Latitude/Longitude									
				Start	End								
Item	Trim / Thin Trees			38.423035 °	38.425140 °								
				-121.529255 °	-121.530742 °								
DWR ID	DWR_RD0999_04_s_2012_6												
Action/Comments													
Trim trees to at least five feet above ground level.

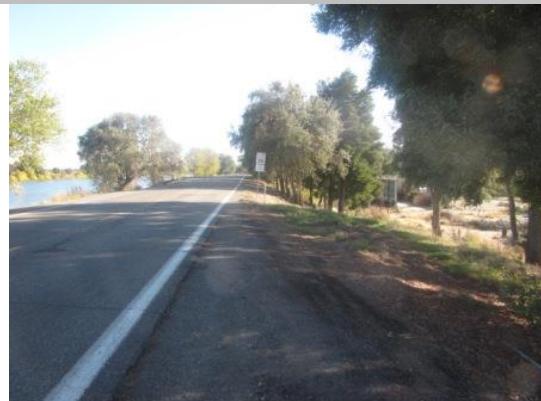
Photo 2 of 2 : FA_2015_RD0999_235_6_20150914_00005.jpg

Looking south at trimmed trees on landside slope and removed fence.

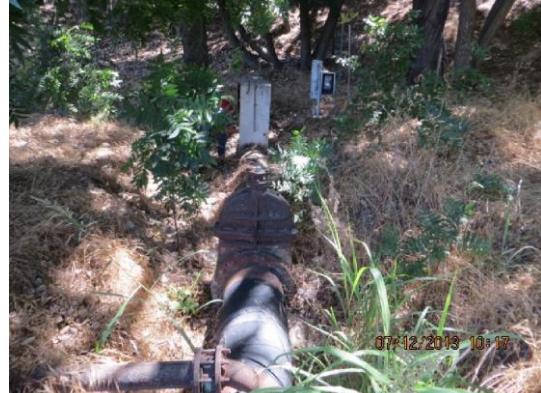
Photo 1 of 3 : UCIP_FA_2015_0545.jpg

LM Start	0.71	Rating **	M	Issue No.	42									
LM End	0.71	Issue Type +	En	Location *	LS									
Category	Supplemental			GPS Latitude/Longitude										
				Start	End									
Item	DWR UCIP Field Study			38.423062 °	38.423062 °									
				-121.529241 °	-121.529241 °									
DWR ID														
Action/Comments														
Inspector Comments: FS_ID:15712 DS_ID:22791 EP_NO: 3973 FS_HLM: 0.709 Repair Type: Non-Urgent Crossing Status: Found UCIP Comments: Slide gate broken on LS toe. Appears it may be abandoned. FIELD_STRUCT_DESC: 18-inch steel stormdrain pipe through the levee 4.7 feet below the crown. air vent in 18-inch steel standpipe on the waterward shoulder. Gate valve on the land side toe (Permit No. 3973, 1962). Originally included in the 1966 O&M manual. FS Date: 07/12/2013

Gate valve on LS toe.

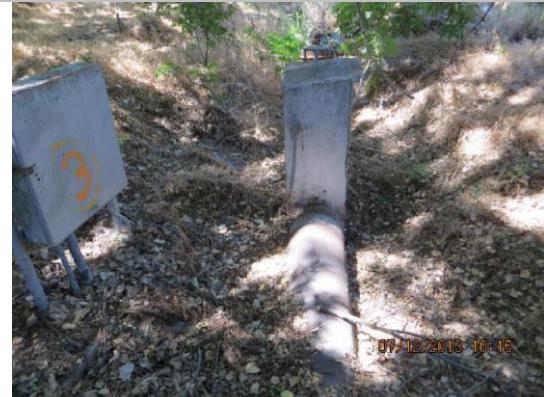
Photo 2 of 3 : UCIP_FA_2015_0546.jpg

Electrical panel, water meter, and gate valve on LS toe.

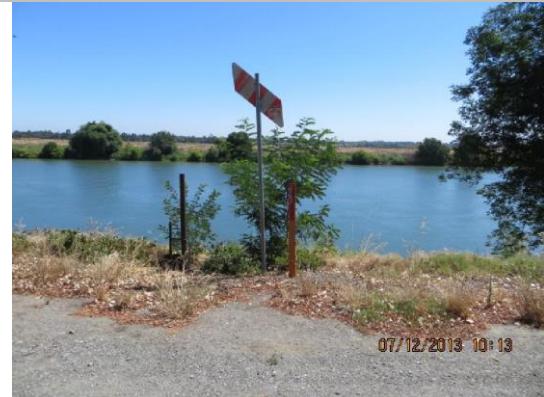
Photo 3 of 3 : UCIP_FA_2015_0547.jpg

Air vent in standpipe on WS shoulder.

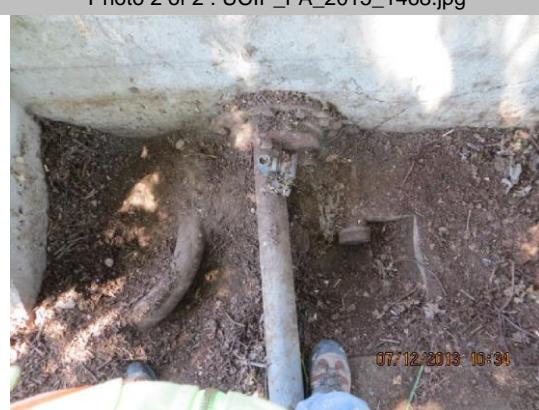
3.5-inch electrical conduit shown at left of 10-inch pipe.

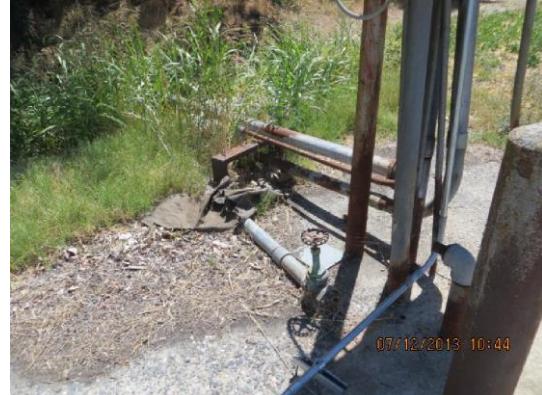
Photo 1 of 3 : UCIP_FA_2015_1472.jpg

LM Start	0.74	Rating **	M	Issue No.	44													
LM End	0.74	Issue Type +	En	Location *	LS													
Category	Supplemental			GPS Latitude/Longitude														
				Start	End													
Item	DWR UCIP Field Study			38.423418 °	38.423418 °													
				-121.529486 °	-121.529486 °													
DWR ID																		
Action/Comments																		
Inspector Comments: FS_ID:15725 DS_ID:22796 EP_NO: 10514 FS_HLM: 0.737 Repair Type: Non-Urgent Crossing Status: Found

Pipe with gate valve off LS toe.

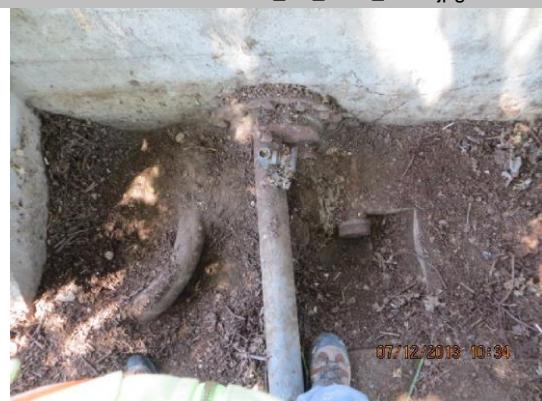
Photo 2 of 3 : UCIP_FA_2015_1473.jpg

Siphon breaker at headwall on WS.

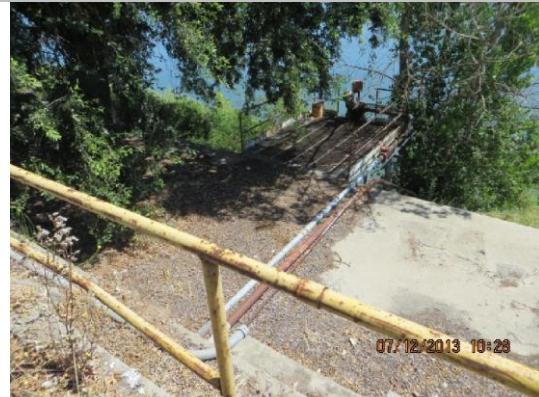
Photo 3 of 3 : UCIP_FA_2015_1474.jpg

Discharge pipe at concrete pad then down slope to water.
